**Date:** April 15, 2020  
**To:** Leanne Bilodeau, Associate Director Sustainability – UBCO Campus Planning and Development  
**From:** Benjamin Butz, B.Sc., B.I.T., and Mary Ann Olson-Russello, M.Sc., R.P.Bio.  
**File:** 19-3150  
**Subject:** Environmental Impact Assessment of the Proposed Lower Innovation Precinct North Multi-use Trail at UBC-Okanagan

## 1.0 INTRODUCTION

## 2.0 PROPOSED WORKS

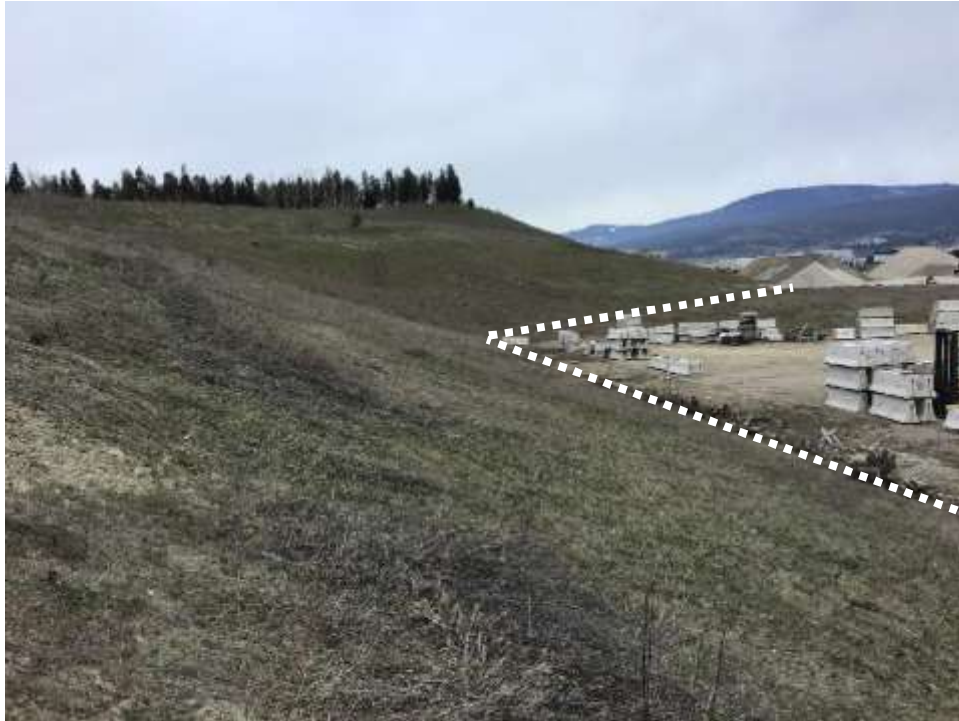
The majority of the proposed LIP North Multi-use Trail expansion falls within a gravel pit (GP) polygon (Photos 1 and 2). This is an anthropogenic polygon with little-to-no habitat value. It was composed of some areas of active gravel pit with no significant vegetation and other areas of disturbed slope with almost entirely invasive vegetation. At the southern end of the GP polygon, on either side of the proposed trail alignment, lies the storm ditch adjacent to parking lot H (Photos 3 and 4). The majority of native plant species within the project area were found within the storm ditch, including black cottonwood, prickly rose, and common cattail. The southern end of the proposed trail extends into an Urban (UR) and Rural (RW) classified polygon. This area is paved and consists of parking lot H.

**Photo 1.** View of the gravel pit (GP) polygon, which encompasses the disturbed hillside. Dotted line shows approximate location of the proposed multi-use trail. Photo facing north (all photos taken April 3, 2020).

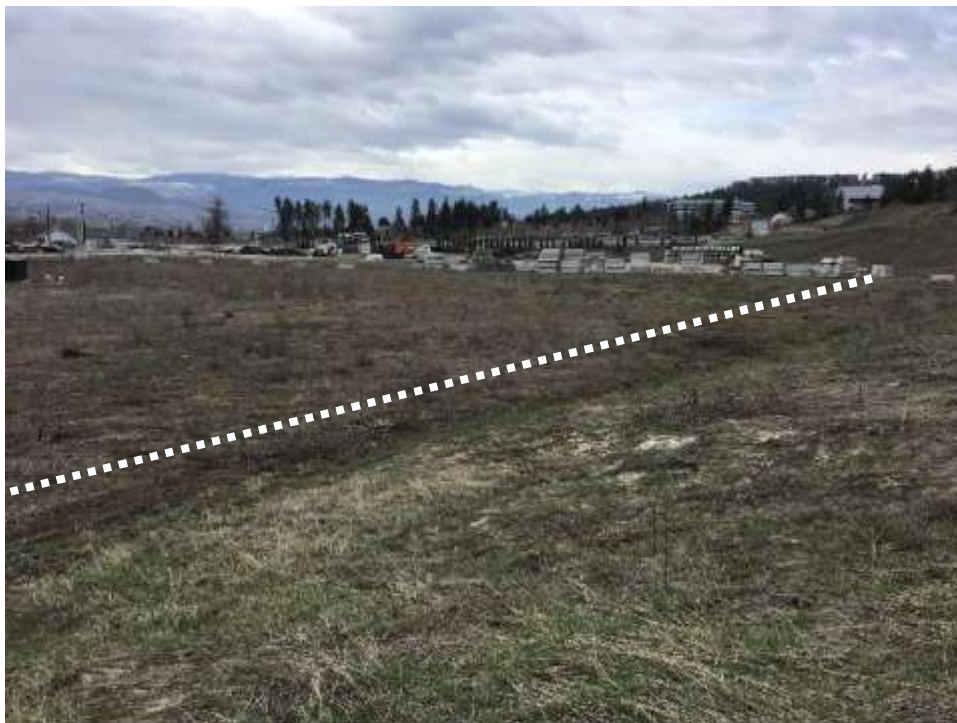
**Photo 2.** Southern view of the gravel pit (GP) polygon, which encompasses a disturbed flat area. Dotted line shows approximate location of proposed walking trail.

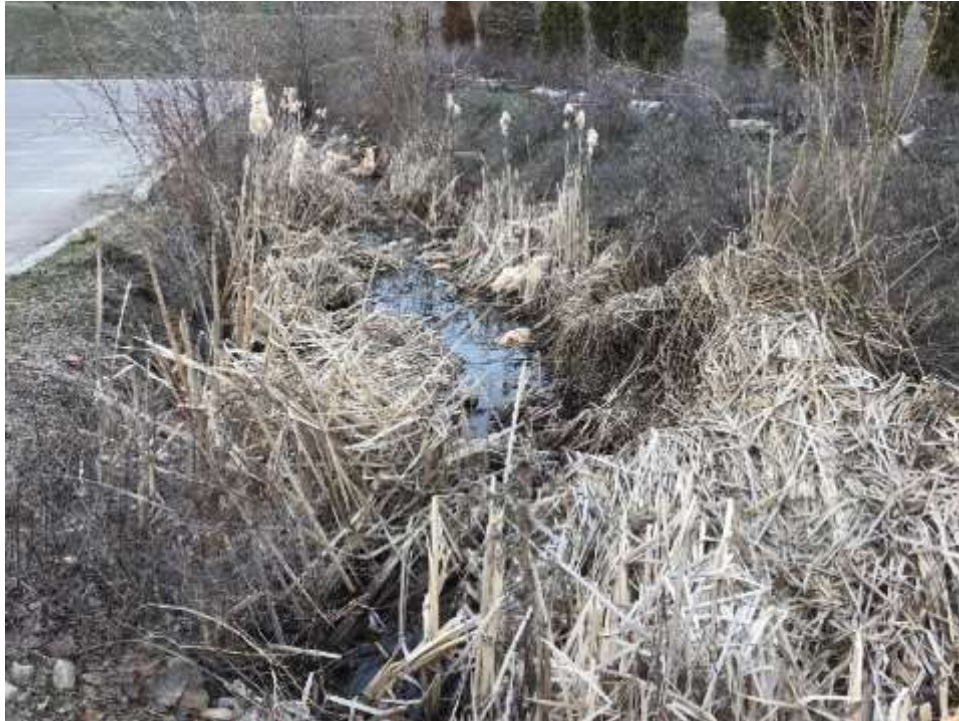
A small portion of the habitat within the project area consists of a storm ditch that supports native vegetation and Great Basin spadefoot breeding habitat. Despite the artificial nature of this ditch, it should be considered environmentally sensitive, as it provides critically important breeding habitat for the spadefoot.

**Photo 3.** West facing view of the cattail march (CT) polygon within the ditch at the south end of the proposed multi-use trail.

- ☐ The primary environmental concern during works will be the potential harm to Great Basin Spadefoot toads. These toads have been historically observed using the ditch at the southern end of the project area during their breeding period (**starting in April and ending in June**). Any work that must take place within this ditch should be done outside of this breeding period.

- ☐ Should work within the ditch be required during the breeding period, a EM may need to perform an amphibian salvage prior to works starting. This will be for the purpose of finding and relocating any Great Basin spadefoot toad eggs/tadpoles that may be present. Due to Great Basin spadefoot toad life history, no adult individuals are likely to be present within the ditch outside of the breeding period.

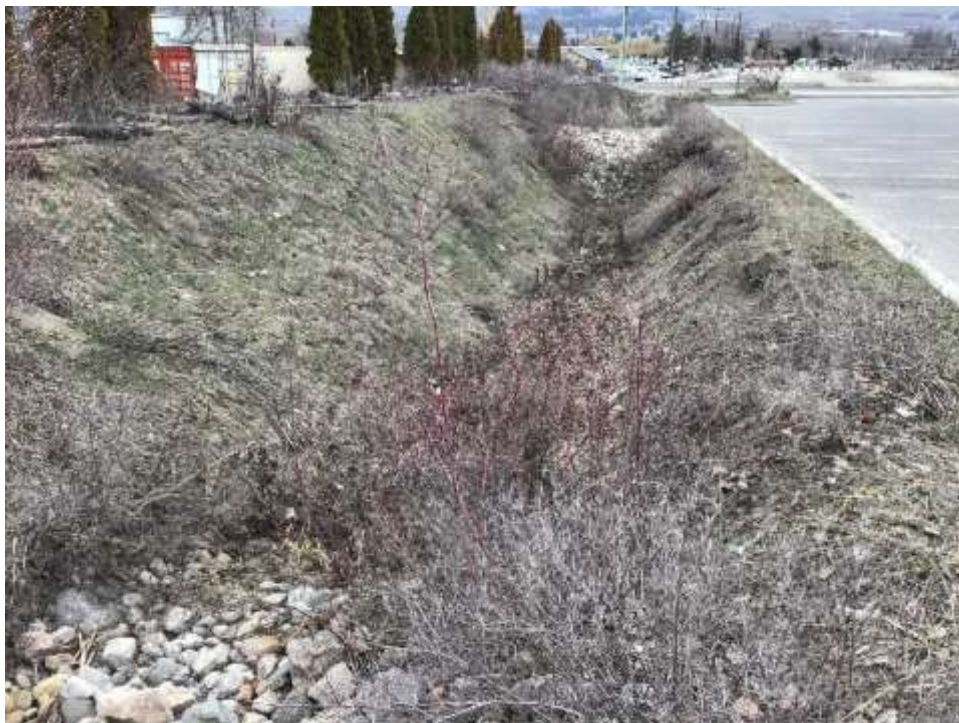
**Photo 4.** East facing view of the ditch at the south end of the proposed walking trail, east of the CT polygon.

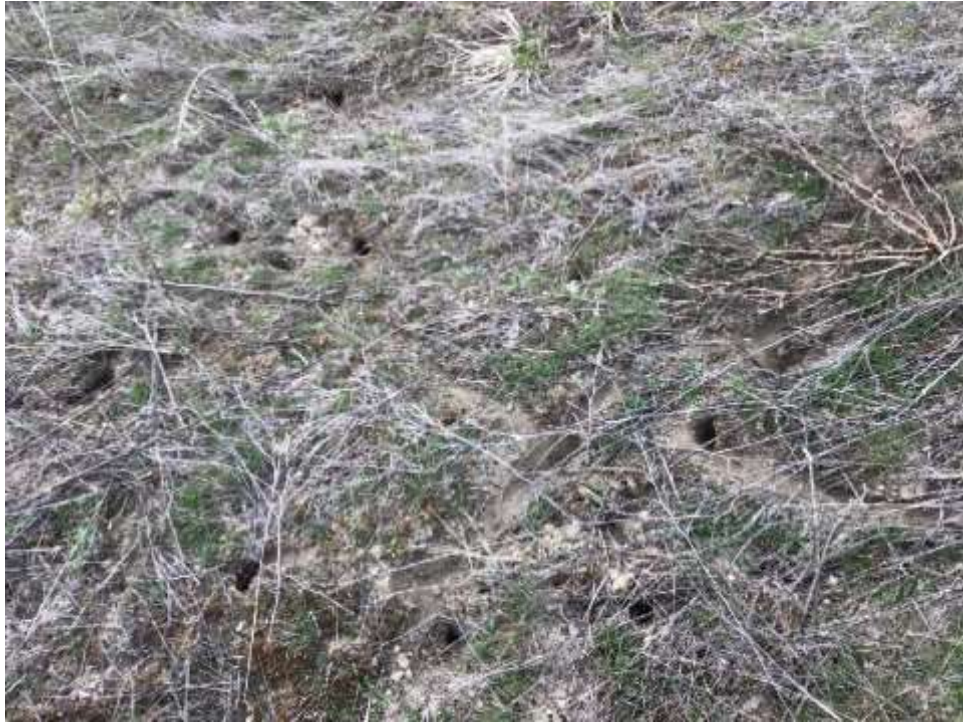
Due to the scope of this assessment, a detailed wildlife assessment of the project area was not conducted. However, *Turdus migratorius* (American Robin) was observed during the assessment. Additionally, large numbers of rodent holes were noted within the project area and on the adjacent slope to the west of the trail alignment (Photo 5). The project area occurs within multiple critical habitat polygons for native snake species-at-risk, including the Great Basin gophersnake, Western rattlesnake, and desert nightsnake. These burrows may be host to such species, however no historical occurrences have been noted within the immediate project area. Given that the storm ditch supports Great Basin spadefoot tadpoles in the spring, it is also likely that adult spadefoots are using the rodent holes for general living and cover.

However, it is probable that Great Basin spadefoot, and other potential species-at-risk use the many rodent burrows throughout the upland area as general living and foraging habitat. Consequently, disturbance should be minimized in this area to what is necessary.

**Photo 5.** View of some of the many rodent holes that occur within the gravel pit (GP) polygon.

- Great Basin spadefoot toads require soft, deep, loose soils in order to burrow below the frost line during the winter or during the hottest parts of the day. The project area of the proposed trail expansion may provide suitable overwintering and burrowing habitat for this species. Should crews come across Great Basin spadefoot toads during works, the EM should be contacted immediately to carry out an amphibian salvage (**250-491-7337**).

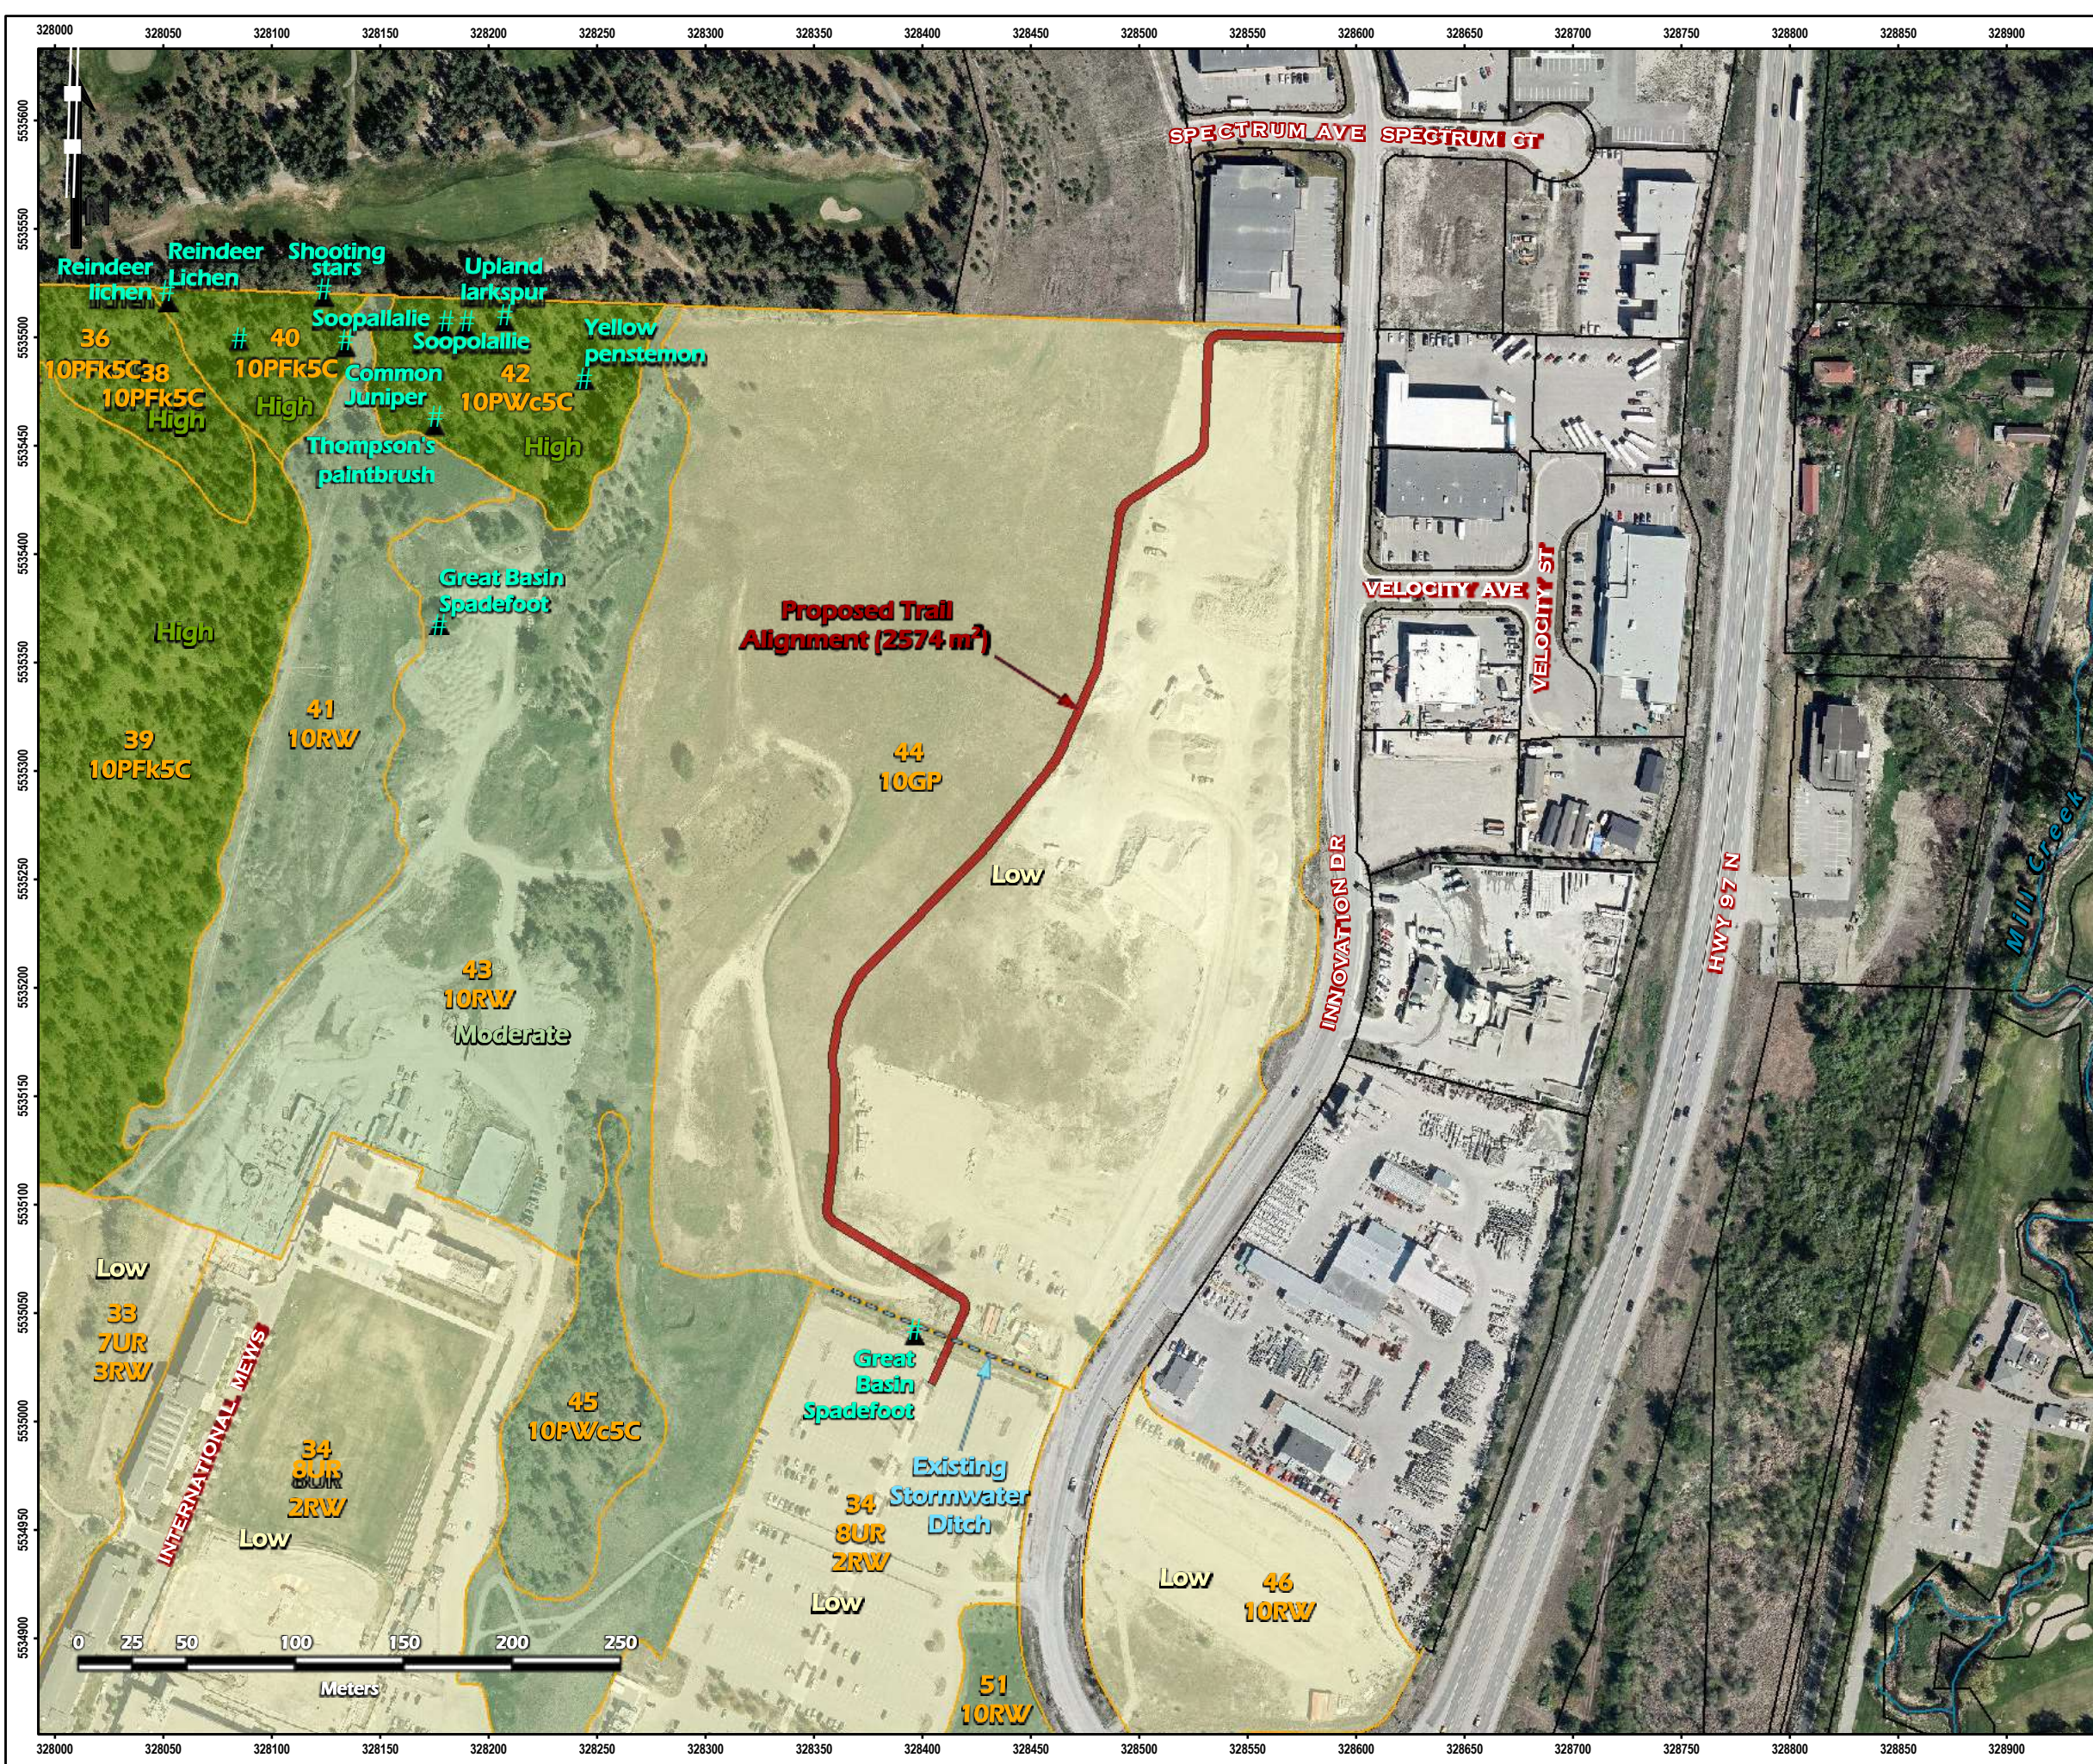
**FIGURE 1**  
*Site Location and Proposed Trail Alignment*

The proposed LIP North Multi-use Trail expansion consists of a 4-metre wide paved trail that will extend from the north end of Parking Lot H to the northern industrial district of the UBCO campus (Figure 1). The trail encompasses approximately 2,574 m<sup>2</sup> and extends across an existing storm ditch which is known to provide habitat for the BC Blue-listed, COSEWIC<sup>1</sup> Threatened, SARA<sup>2</sup> Threatened Great Basin Spadefoot (*Spea intermontana*).

The trail alignment in the proximity of the storm ditch has since changed from the toe of slope at the western end of the ditch, where cuts and fills would have been necessary, to the middle of the ditch. Immediately north of the ditch, the trail alignment shifts to the west and then follows the toe of slope north, prior to connecting with Innovation Drive at the north end (Figure 1).
