**Date:** April 15, 2020  
**To:** Leanne Bilodeau, Associate Director Sustainability – UBCO Campus Planning and Development  
**From:** Benjamin Butz, B.Sc., B.I.T., and Mary Ann Olson-Russello, M.Sc., R.P.Bio.  
**File:** 19-3150  
**Subject:** Environmental Impact Assessment of the Proposed Lower Innovation Precinct North Multi-use Trail at UBCO-Okanagan

## 1.0 INTRODUCTION

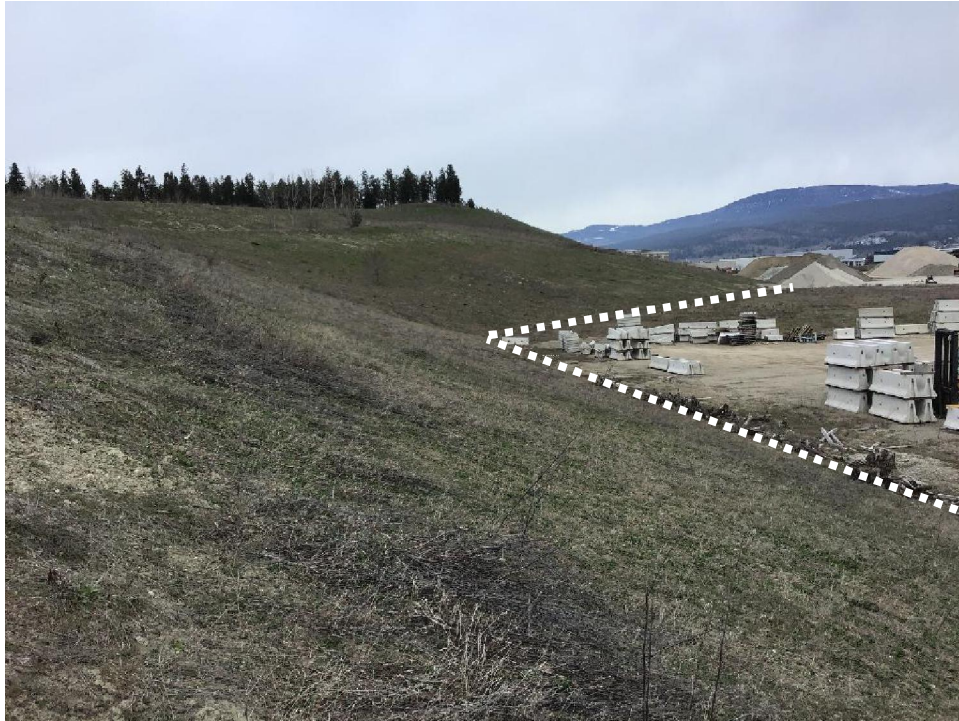
The majority of the proposed LIP North Multi-use Trail expansion falls within a gravel pit (GP) polygon (Photos 1 and 2). This is an anthropogenic polygon with little-to-no habitat value. It was composed of some areas of active gravel pit with no significant vegetation and other areas of disturbed slope with almost entirely invasive vegetation. At the southern end of the GP polygon, on either side of the proposed trail alignment, lies the storm ditch adjacent to parking lot H (Photos 3 and 4). The majority of native plant species within the project area were found within the storm ditch, including black cottonwood, prickly rose, and common cattail. The southern end of the proposed trail extends into an Urban (UR) and Rural (RW) classified polygon. This area is paved and consists of parking lot H.

**Photo 1.** View of the gravel pit (GP) polygon, which encompasses the disturbed hillside. Dotted line shows approximate location of the proposed multi-use trail. Photo facing north (all photos taken April 3, 2020).

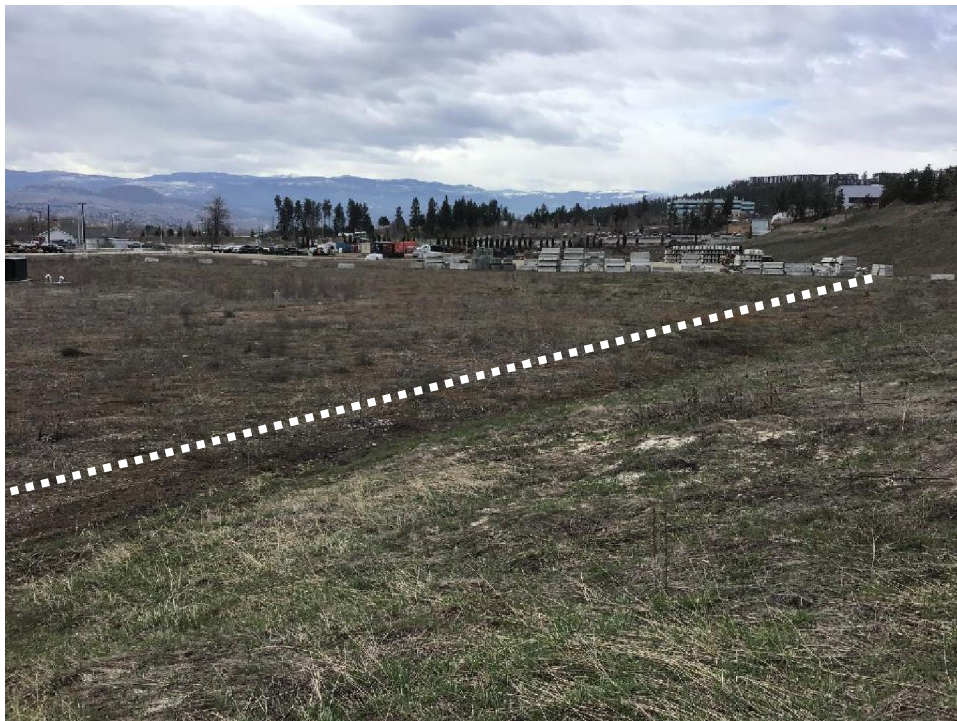
**Photo 2.** Southern view of the gravel pit (GP) polygon, which encompasses a disturbed flat area. Dotted line shows approximate location of proposed walking trail.

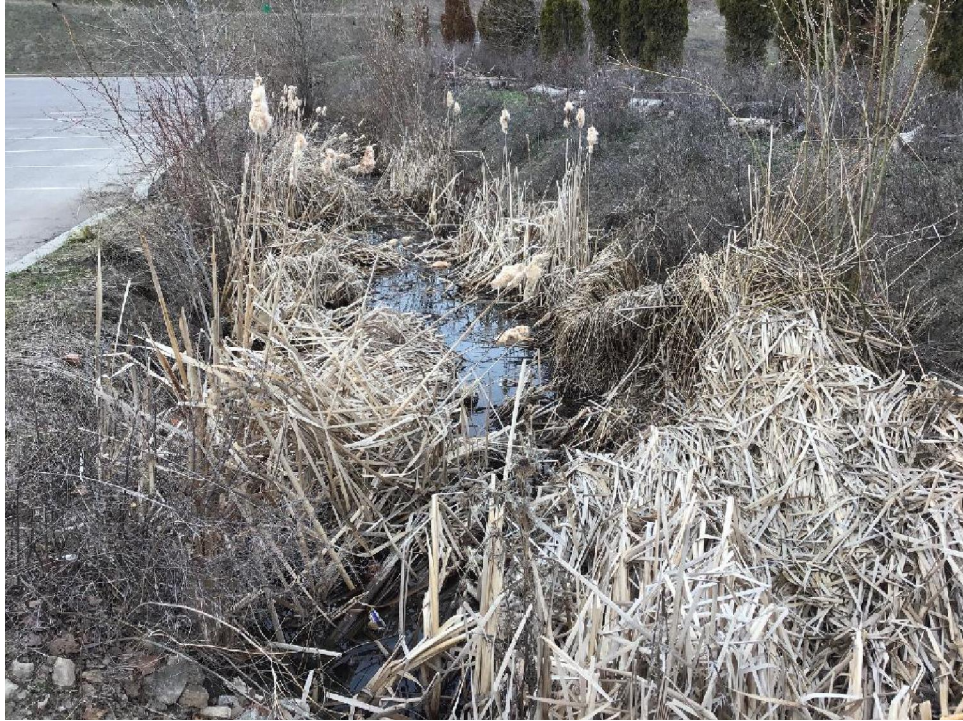
A small portion of the habitat within the project area consists of a storm ditch that supports native vegetation and Great Basin spadefoot breeding habitat. Despite the artificial nature of this ditch, it should be considered environmentally sensitive, as it provides critically important breeding habitat for the spadefoot.

**Photo 3.** West facing view of the cattail march (CT) polygon within the ditch at the south end of the proposed multi-use trail.

- The primary environmental concern during works will be the potential harm to Great Basin Spadefoot toads. These toads have been historically observed using the ditch at the southern end of the project area during their breeding period (**starting in April and ending in June**). Any work that must take place within this ditch should be done outside of this breeding period.

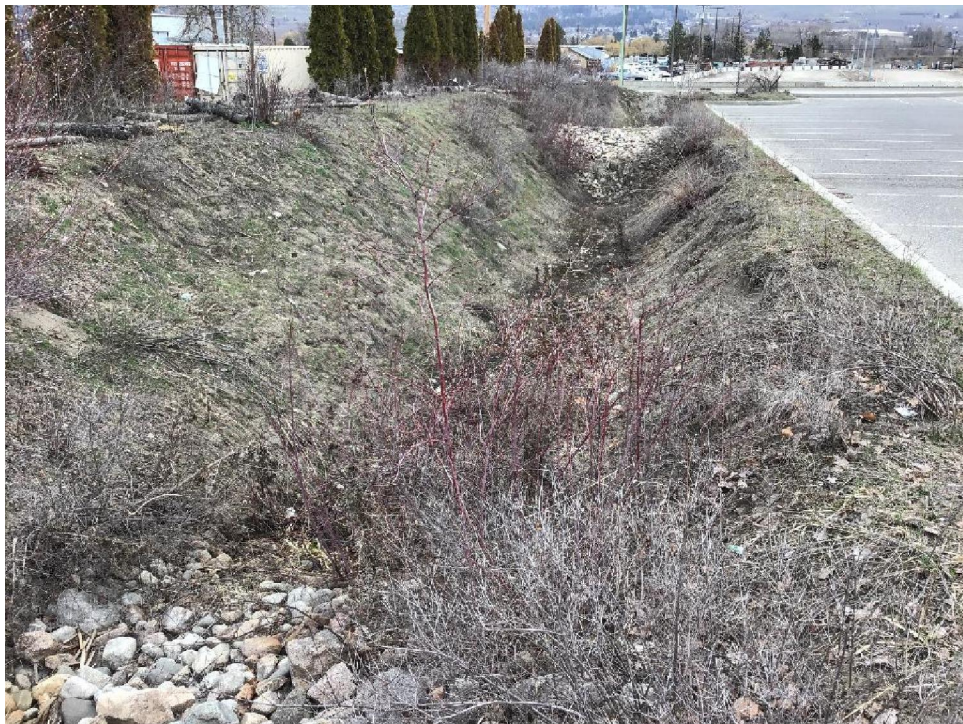
**Photo 4.** East facing view of the ditch at the south end of the proposed walking trail, east of the CT polygon.

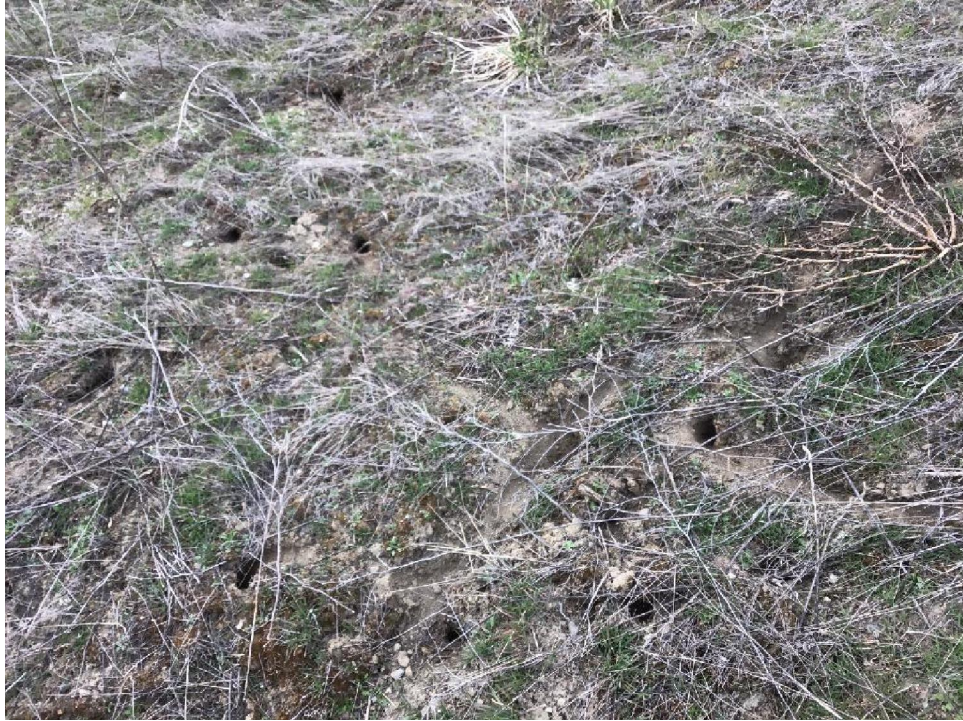
Due to the scope of this assessment, a detailed wildlife assessment of the project area was not conducted. However, *Turdus migratorius* (American Robin) was observed during the assessment. Additionally, large numbers of rodent holes were noted within the project area and on the adjacent slope to the west of the trail alignment (Photo 5). The project area occurs within multiple critical habitat polygons for native snake species-at-risk, including the Great Basin gophersnake, Western rattlesnake, and desert nightsnake. These burrows may be host to such species, however no historical occurrences have been noted within the immediate project area. Given that the storm ditch supports Great Basin spadefoot tadpoles in the spring, it is also likely that adult spadefoots are using the rodent holes for general living and cover.

However, it is probable that Great Basin spadefoot, and other potential species-at-risk use the many rodent burrows throughout the upland area as general living and foraging habitat. Consequently, disturbance should be minimized in this area to what is necessary.

**Photo 5.** View of some of the many rodent holes that occur within the gravel pit (GP) polygon.

- Great Basin spadefoot toads require soft, deep, loose soils in order to burrow below the frost line during the winter or during the hottest parts of the day. The project area of the proposed trail expansion may provide suitable overwintering and burrowing habitat for this species. Should crews come across Great Basin spadefoot toads during works, the EM should be contacted immediately to carry out an amphibian salvage (**250-491-7337**).

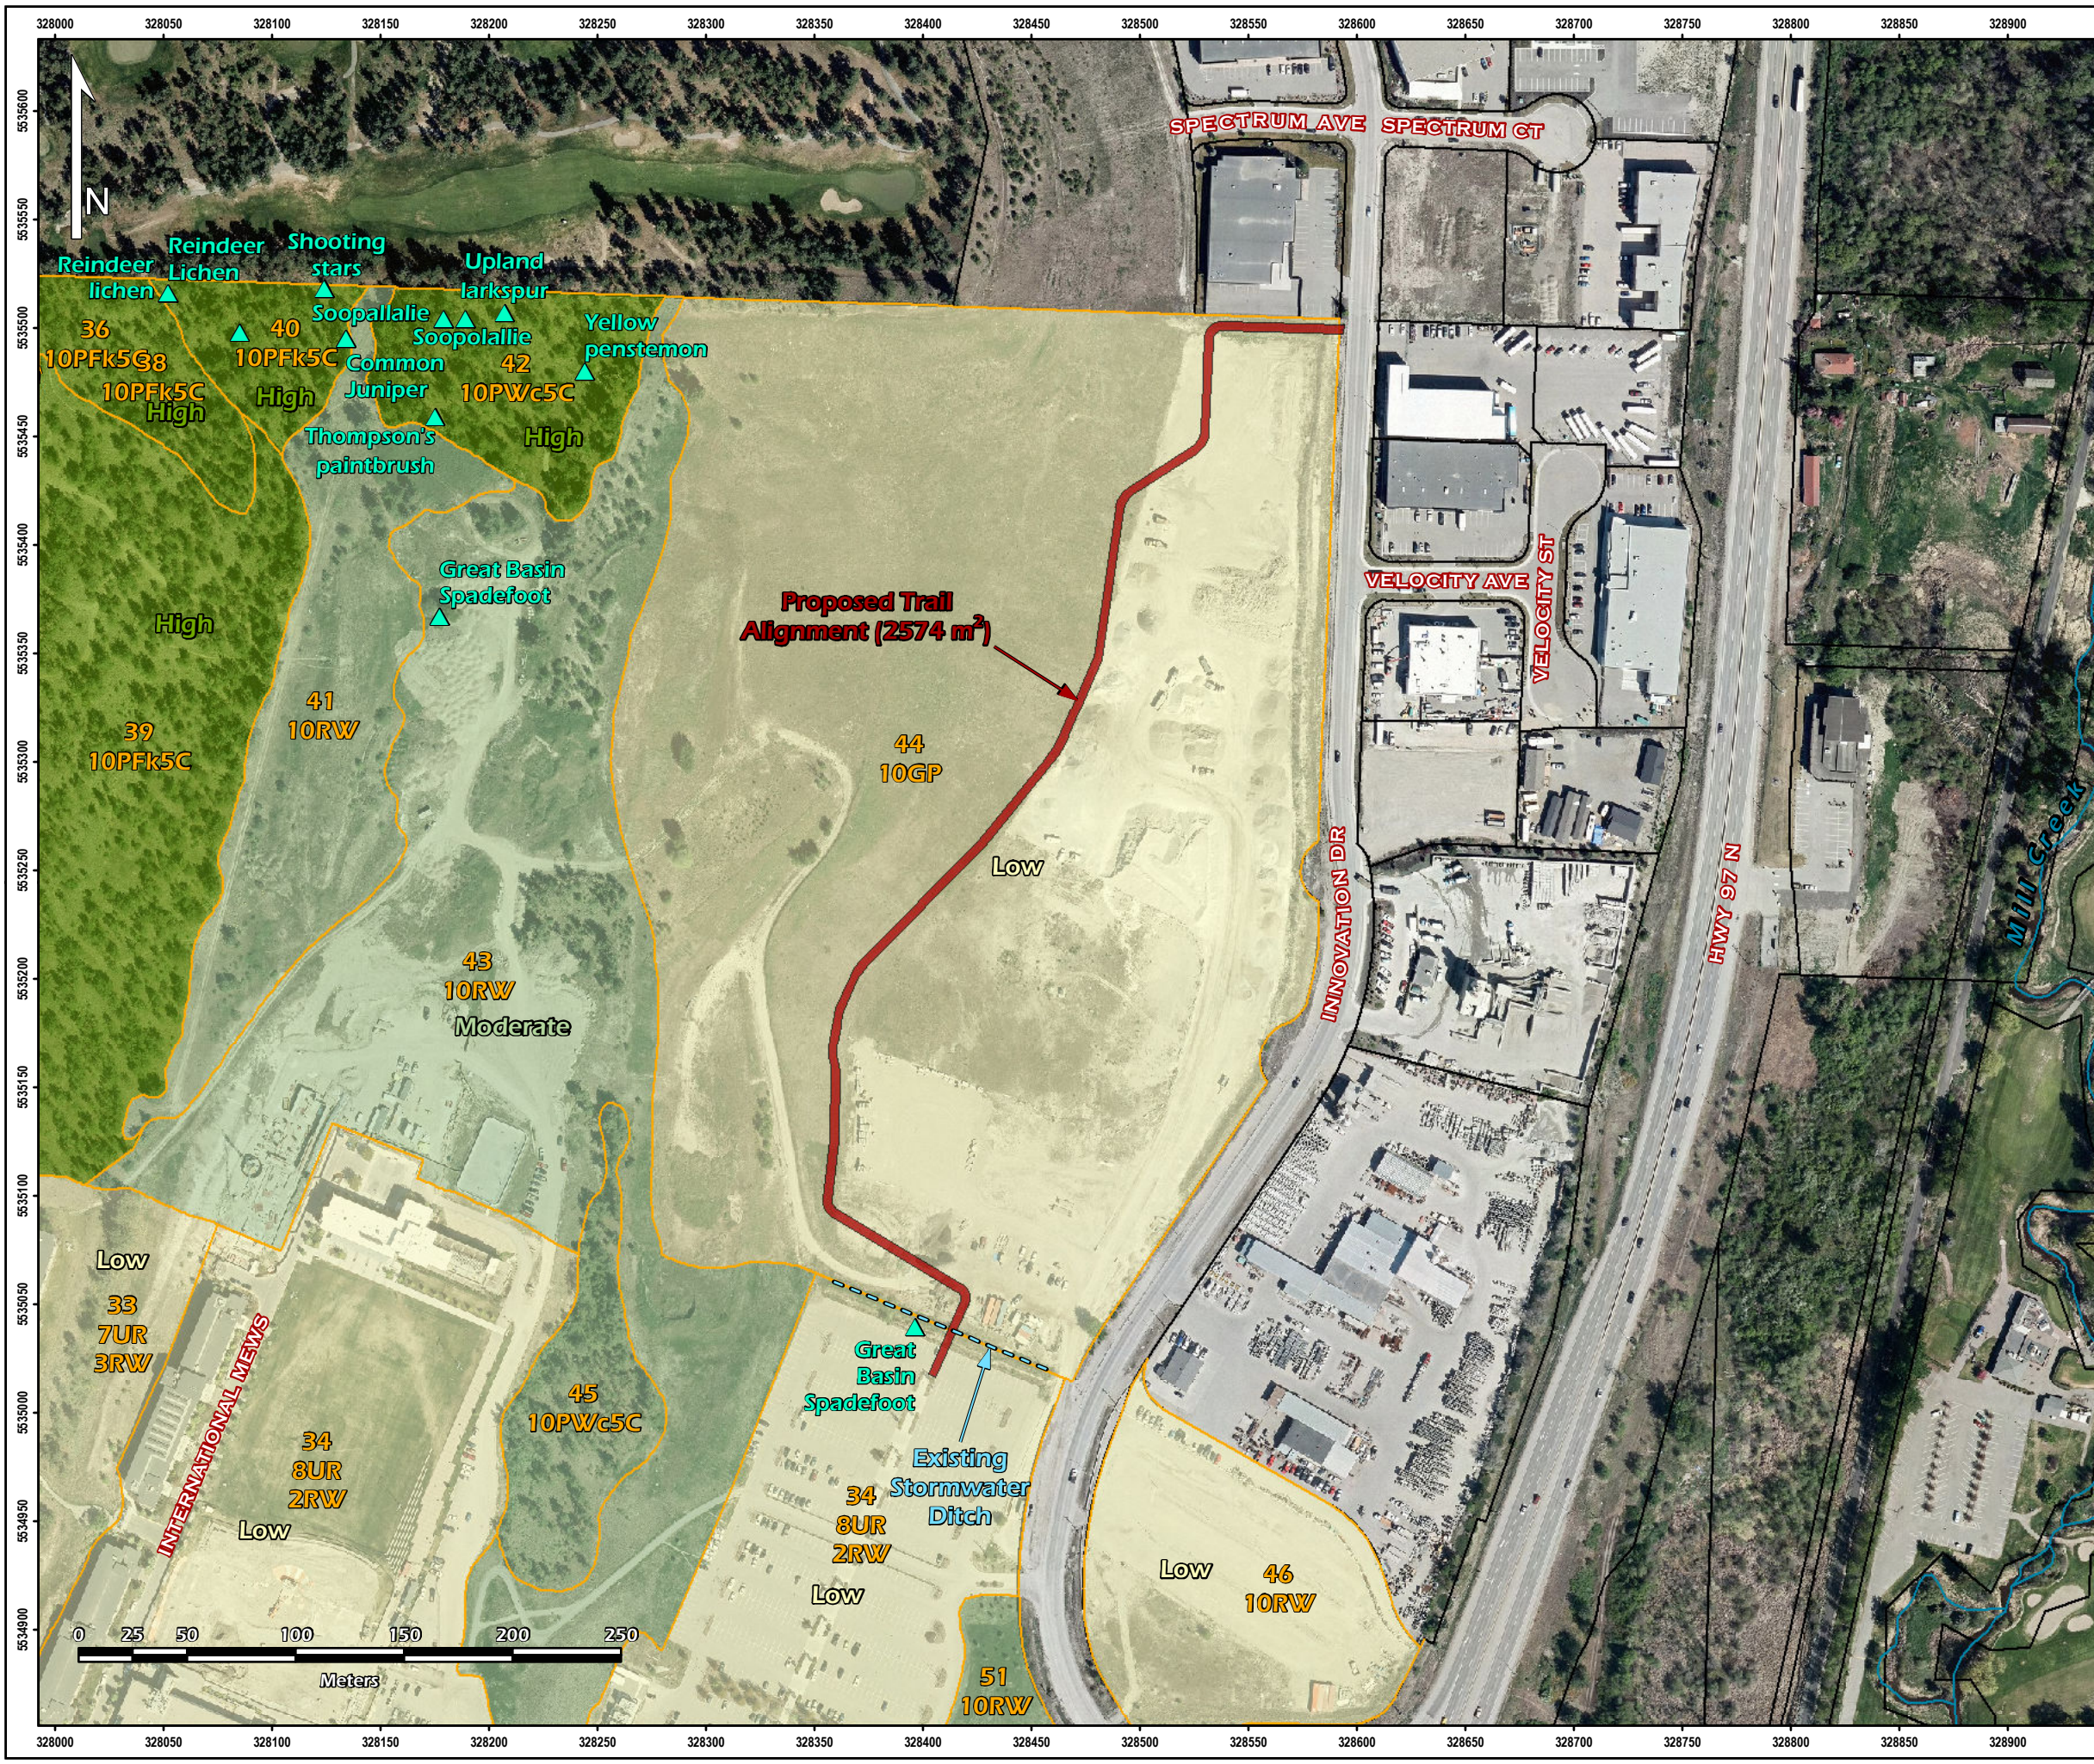
**FIGURE 1**  
**Site Location and Proposed Trail Alignment**

The proposed LIP North Multi-use Trail expansion consists of a 4-metre wide paved trail that will extend from the north end of Parking Lot H to the northern industrial district of the UBCO campus (Figure 1). The trail encompasses approximately 2,574 m<sup>2</sup> and extends across an existing storm ditch which is known to provide habitat for the BC Blue-listed, COSEWIC<sup>1</sup> Threatened, SARA<sup>2</sup> Threatened Great Basin Spadefoot (*Spea intermontana*).

The trail alignment in the proximity of the storm ditch has since changed from the toe of slope at the western end of the ditch, where cuts and fills would have been necessary, to the middle of the ditch. Immediately north of the ditch, the trail alignment shifts to the west and then follows the toe of slope north, prior to connecting with Innovation Drive at the north end (Figure 1).
